PROMOTING ACTIVITY

HOW DESIGN CHOICES INFLUENCE PHYSICAL ACTIVITY

Project Description: The primary focus of this study is to determine how design decisions may influence human behavior. Specific characteristics of four recently built student residences at the University of British Columbia (UBC) will be evaluated. Each residence is a tower typology of roughly the same size and scale. Different design characteristics are present in each tower staircase. With all other factors being equal, the project aims to see which design characteristics encouraged the most stair use by students. A secondary goal is to engage with a key client to collaboratively undertake mutually beneficial research, as a pilot for a general aspiration to learn from our work and provide added value to our clients.

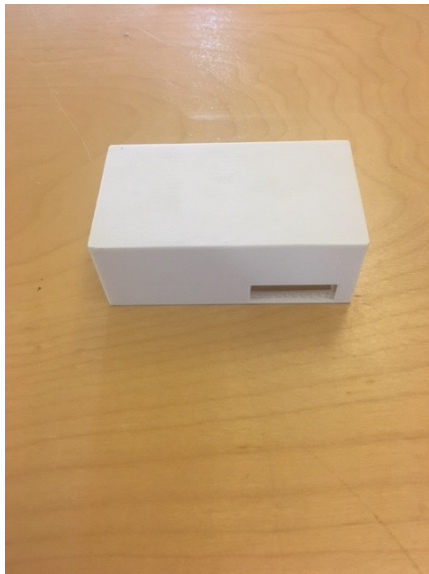
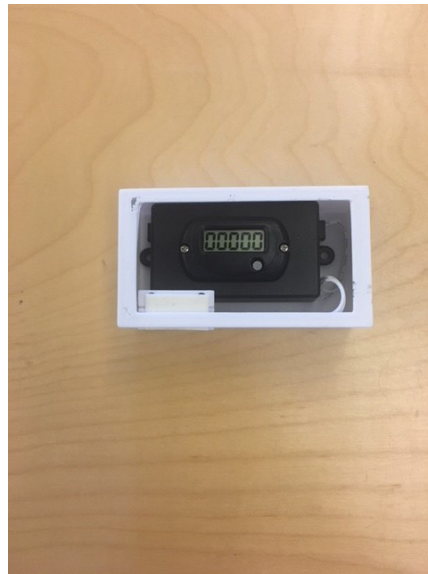
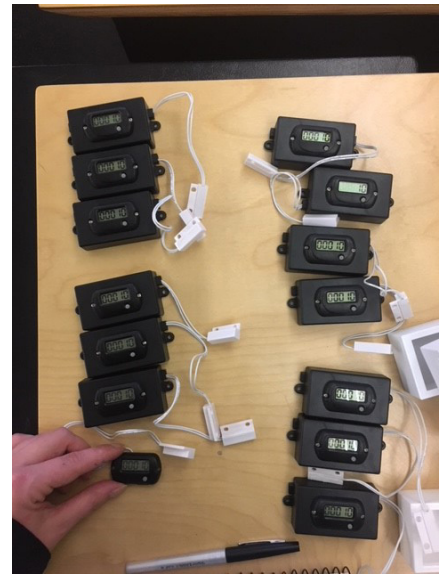
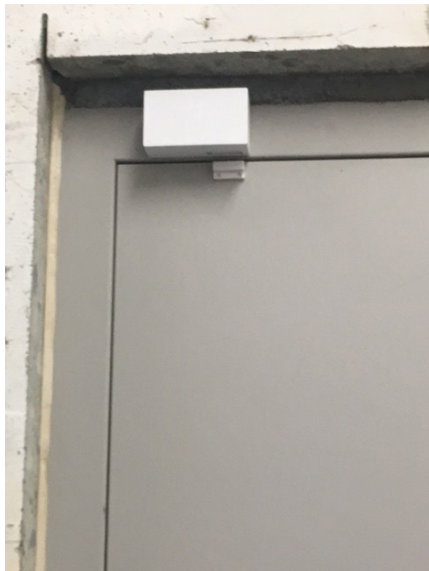
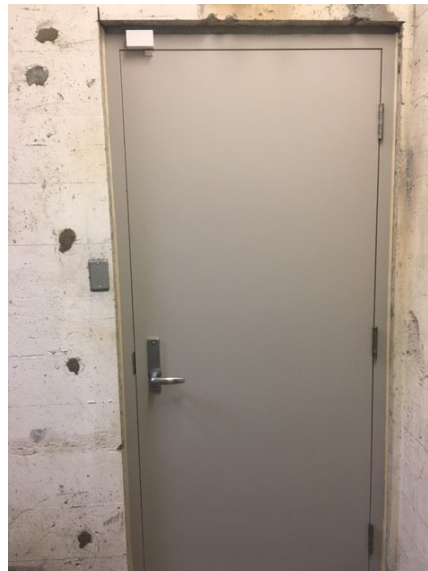
PHOTOS - MOCK UP TESTING

To avoid tampering with the reset button on the device and to be as inconspicuous as possible, protective covers were 3D printed and painted to match the buildings door frames. The devices and covers were installed with double sided tape to avoid any permanent damage or need for tools on site.

1. Device Housing exterior
2. Device Housing Interior
3. Device testing
4. Mock up
5. Mock up

A sample device was ordered and tested at the Perkins and Will Vancouver office over two separate one-week intervals. For the first week, the device was installed above the door which was opened and closed a set number of times to test the overall accuracy of the device. For the second week the counter was allowed to run in order to obtain a full weeks count and to ensure that the device would not reset itself during that time. Satisfied with the results, more counters were ordered to be installed in the towers.

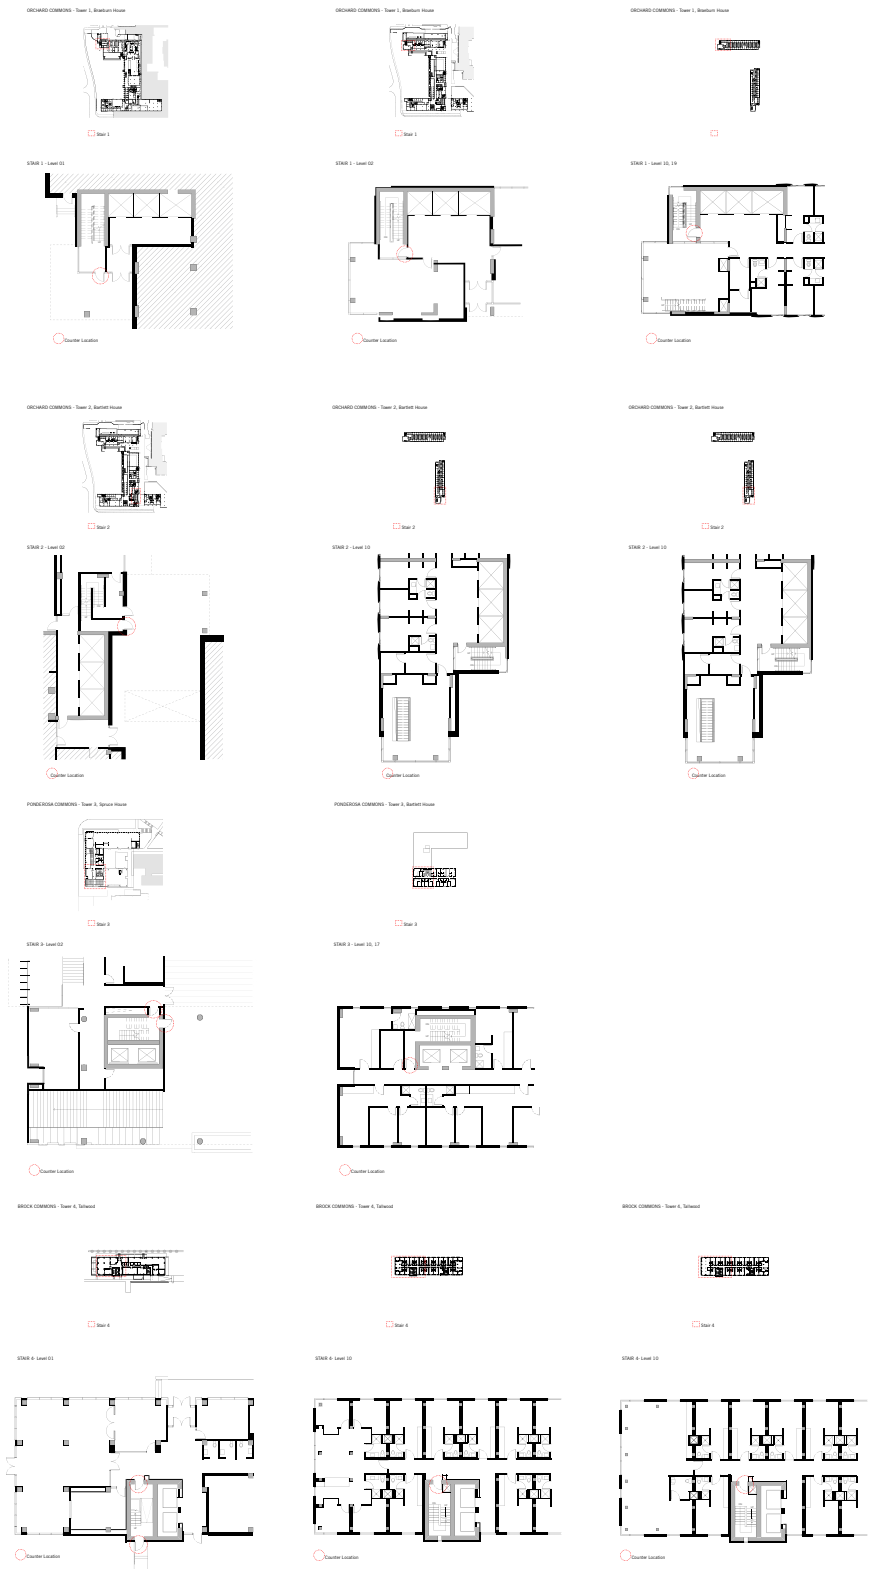
TABLE 3.2 - STAIR DIAGRAMS

See Appendix C for full size diagrams

Data was collected over a one week period. On the ground level, when the stairwell had more than one door, both the entry and exit doors were measured, and the numbers added together for the ground level total. (Table 3.2 – Stair Diagrams – Appendix C)

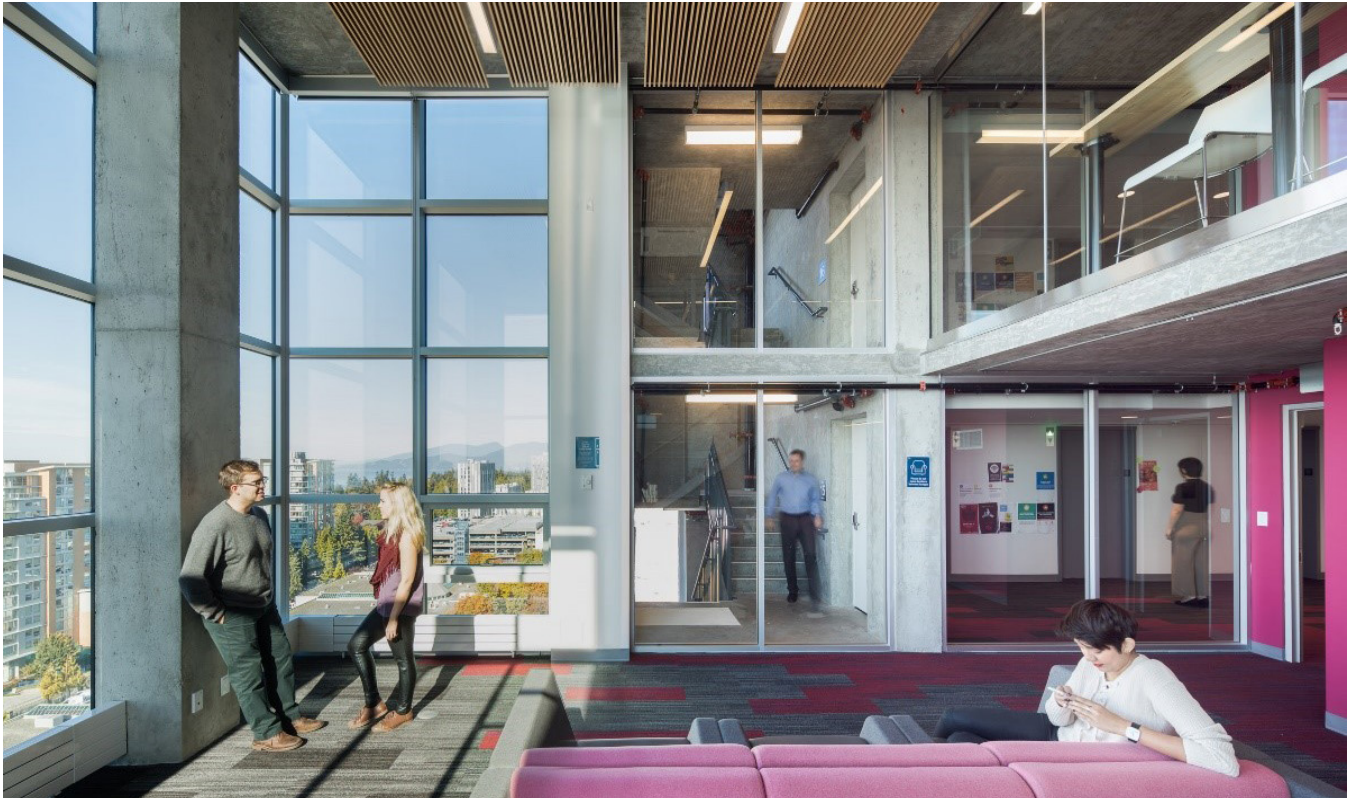
Figure 1.2 - Configuration 1 – Orchard Commons, Braeburn House. Adjacency of glazed exit stair to student lounge. (Credit: Michael Elkan)

A defining feature of Orchard Commons are the residence lounges found in each of the two residential towers. The lounges are three-storey interconnected spaces that act as a type of living room for three floors of student residents. While the lounges in the two buildings are almost identical, there is one key difference between them. In the north tower, Braeburn House, there is an exit stair that passes by the lounges – a glass wall separates the stair from the lounge (Figure 1.2, Appendix A). In the south tower, Bartlett House, this connection with the residence lounges does not exist – the stair only has windows to the outside world for most of its run, and some glazing into the elevator lobby and corridor (Figure 2.2, Appendix A).

The adjacency of the stair to the lounges in the north tower is important. Our assumption during design was that the opportunity to travel up and down in the building while getting a peek into the other floor lounges would be a powerful enticement to encourage residents into the stair. There is a long history of stairs being used as a device ‘to see and be seen’. The expectation was that the social reward that was enabled by this configuration, and characteristics of the space, would act to influence behavior. The fact that the two towers, more or less identical in most ways, have this key difference makes a comparative analysis straight-forward.

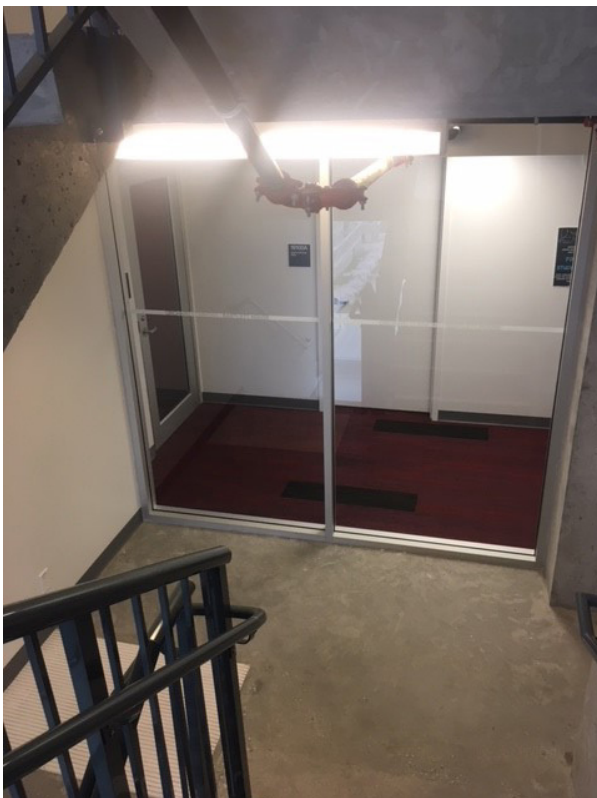
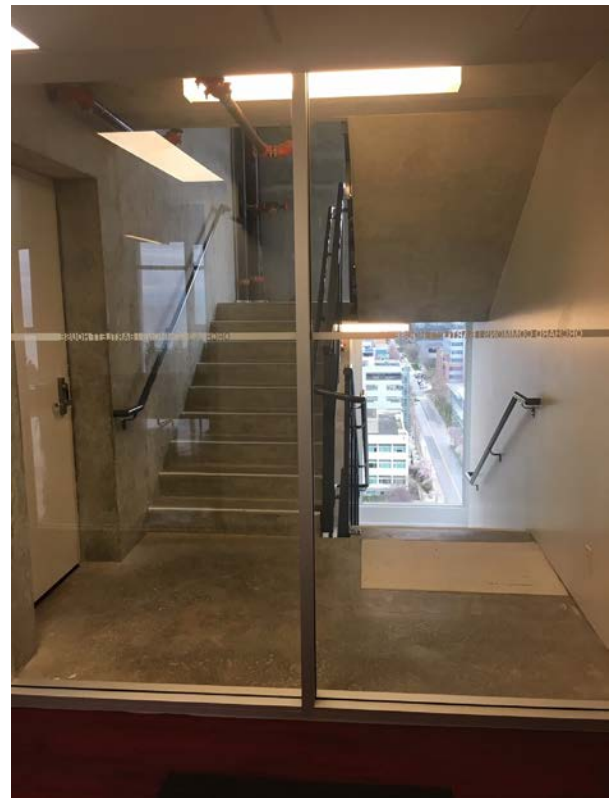
Figure 2.2 - Configuration 2 – Orchard Commons, Bartlett House. Adjacency of glazed exit stair to Main Corridor.

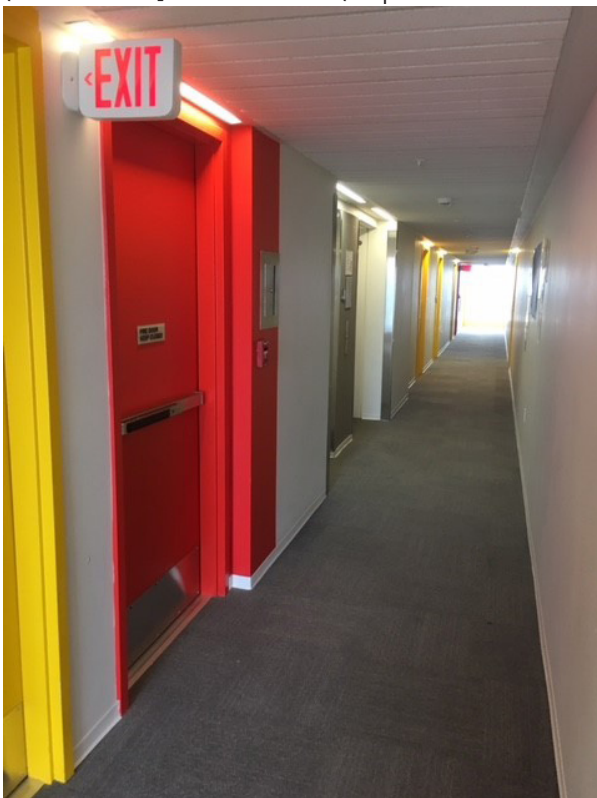
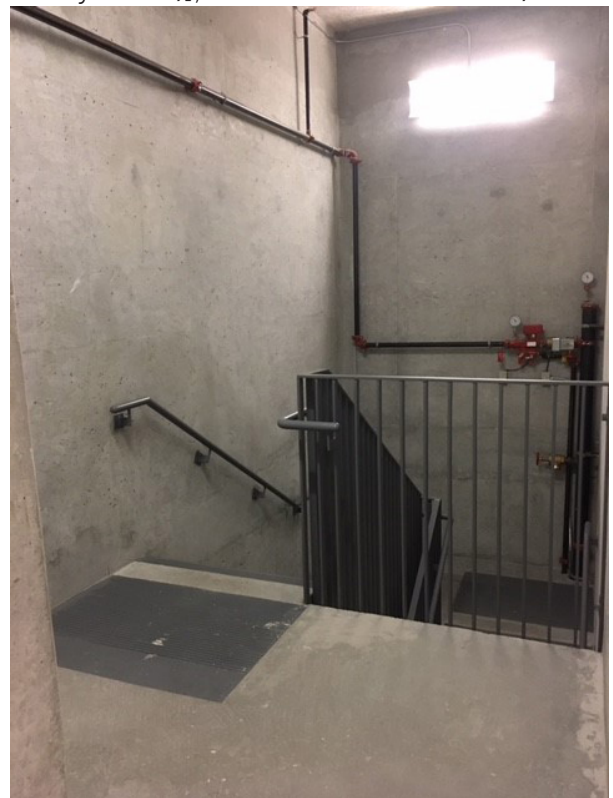
Figure 3.2 - Configuration 3 – Ponderosa Commons, Spruce House. Adjacency of exit stair on main corridor, no glazing.

Ponderosa Commons (Figure 3.1 Appendix A), a mixed-use student residence on campus completed in 2015 (Kuwabara Payne McKenna Blumberg Architects and Hughes Condon Marler Architects) features a conventional exit stair with no glazing or views. Brightly coloured exit doors were used to differentiate the stairs from the rest of the corridor (Figure 3.2, Appendix A)

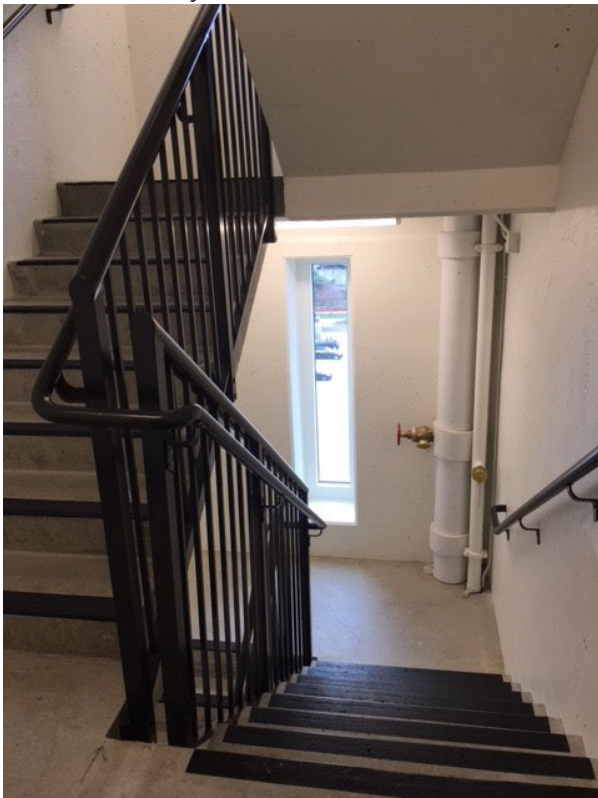
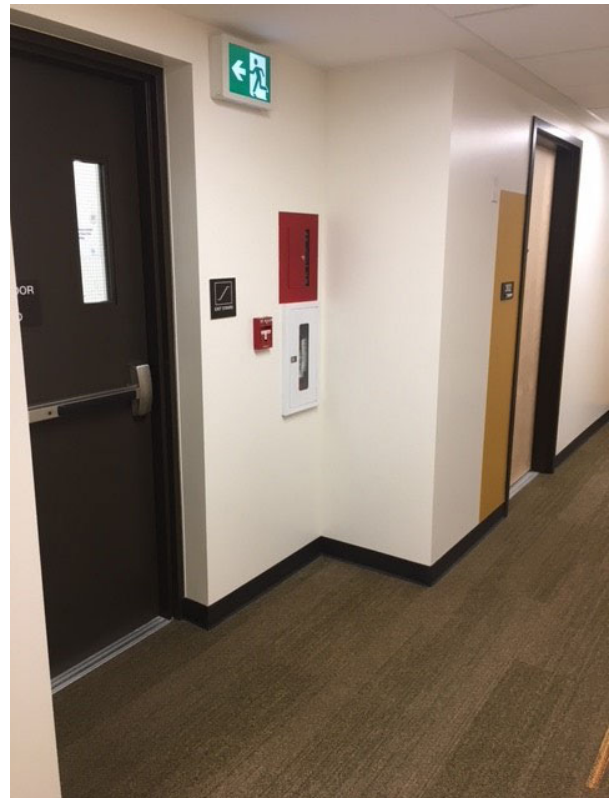
Figure 4.2 - Configuration 4: Brock Commons, Tall Wood House. Adjacency of exit stair on Main Corridor. Minimal interior and exterior glazing.

Brock Commons (Figure 4.1, Appendix A), a dedicated upper year and graduate student residence, completed in 2017 (Acton Ostry Architects), features an exit stair that has a small slot window with views to the exterior and a “narrowlite” door that allows overlook into the main corridor (Figure 4.2, Appendix A)

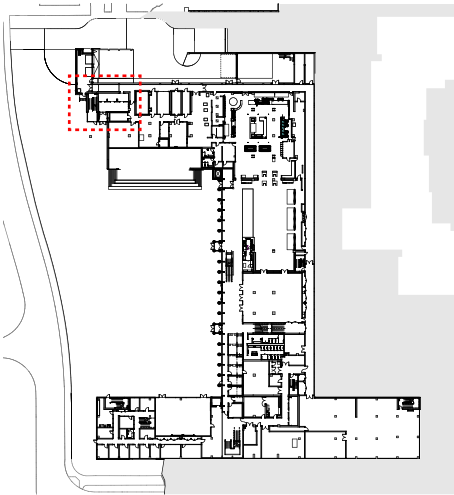
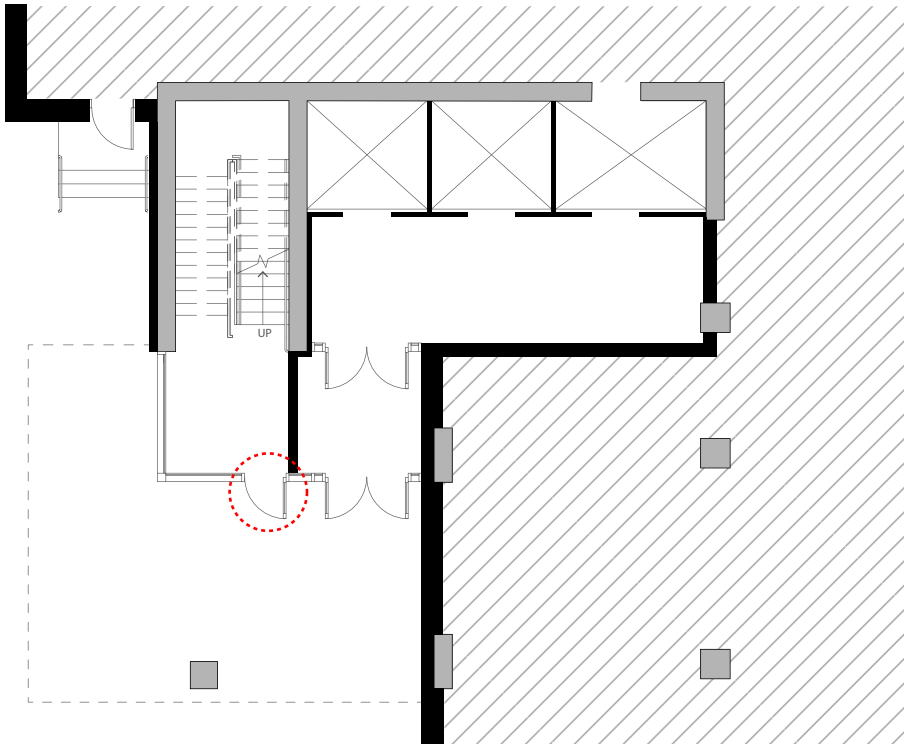
STAIR 1 - BRAEBURN HOUSE, ORCHARD COMMONS - LEVEL 1

Counter Location

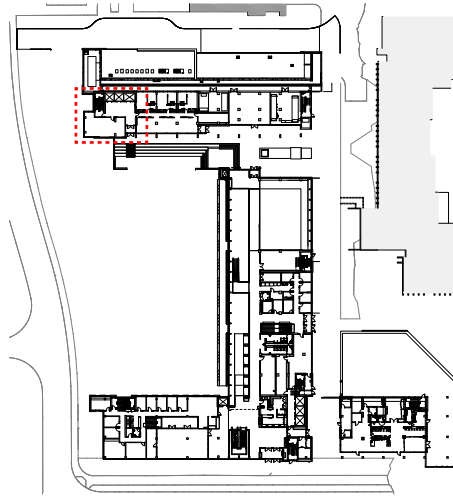
STAIR 1 - BRAEBURN HOUSE, ORCHARD COMMONS - LEVEL 2

Counter Location

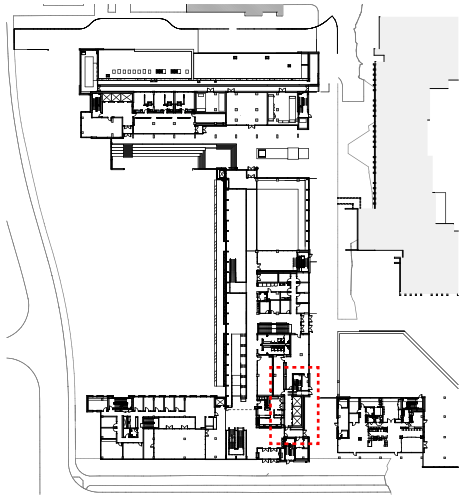
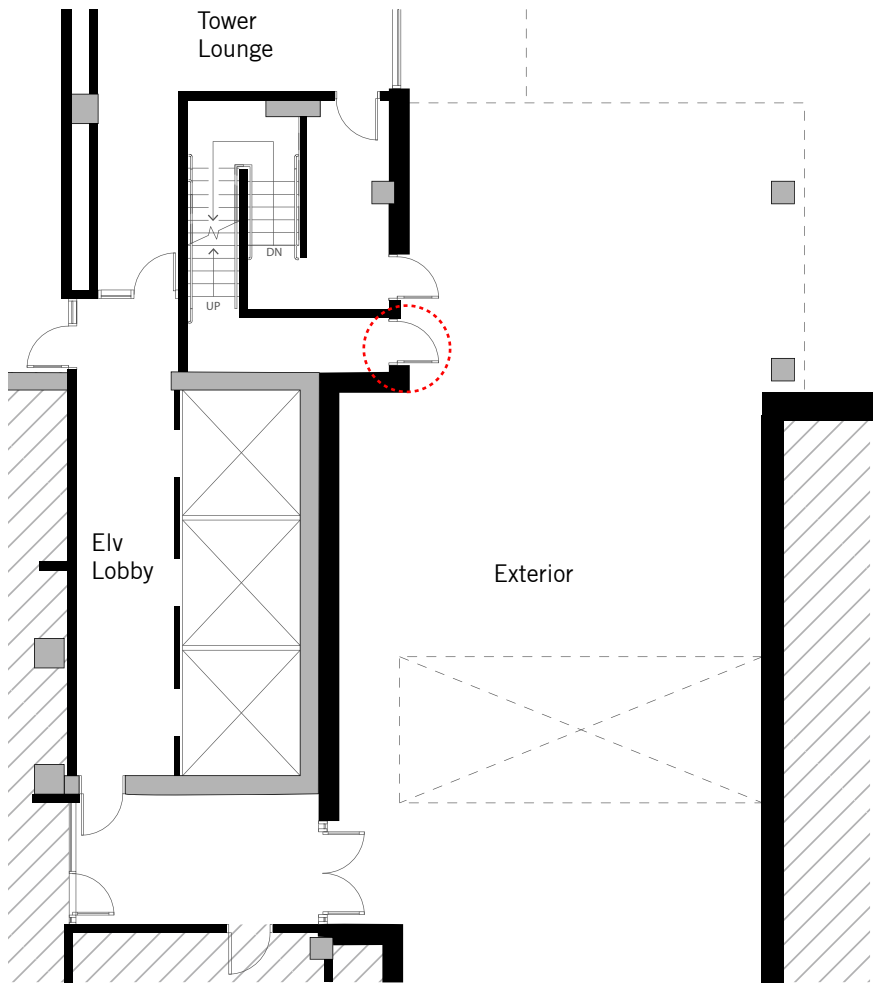
STAIR 2 - BARTLETT HOUSE, ORCHARD COMMONS - LEVEL 2

Counter Location

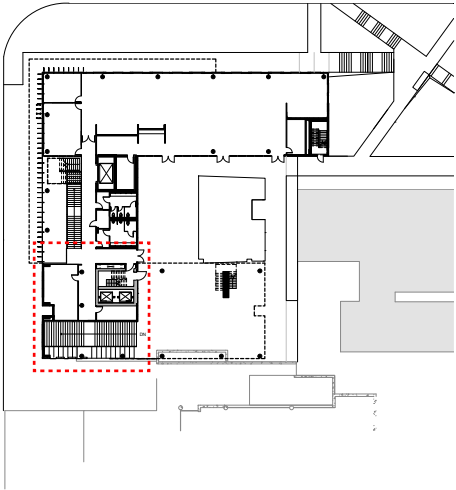
STAIR 3 - SPRUCE HOUSE, PONDEROSA COMMONS - LEVEL 2

Counter Location

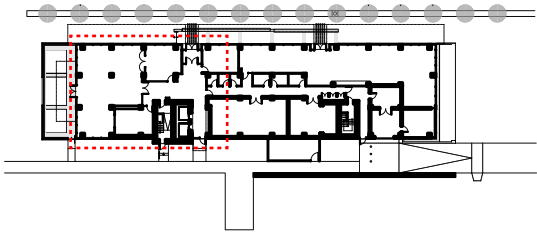
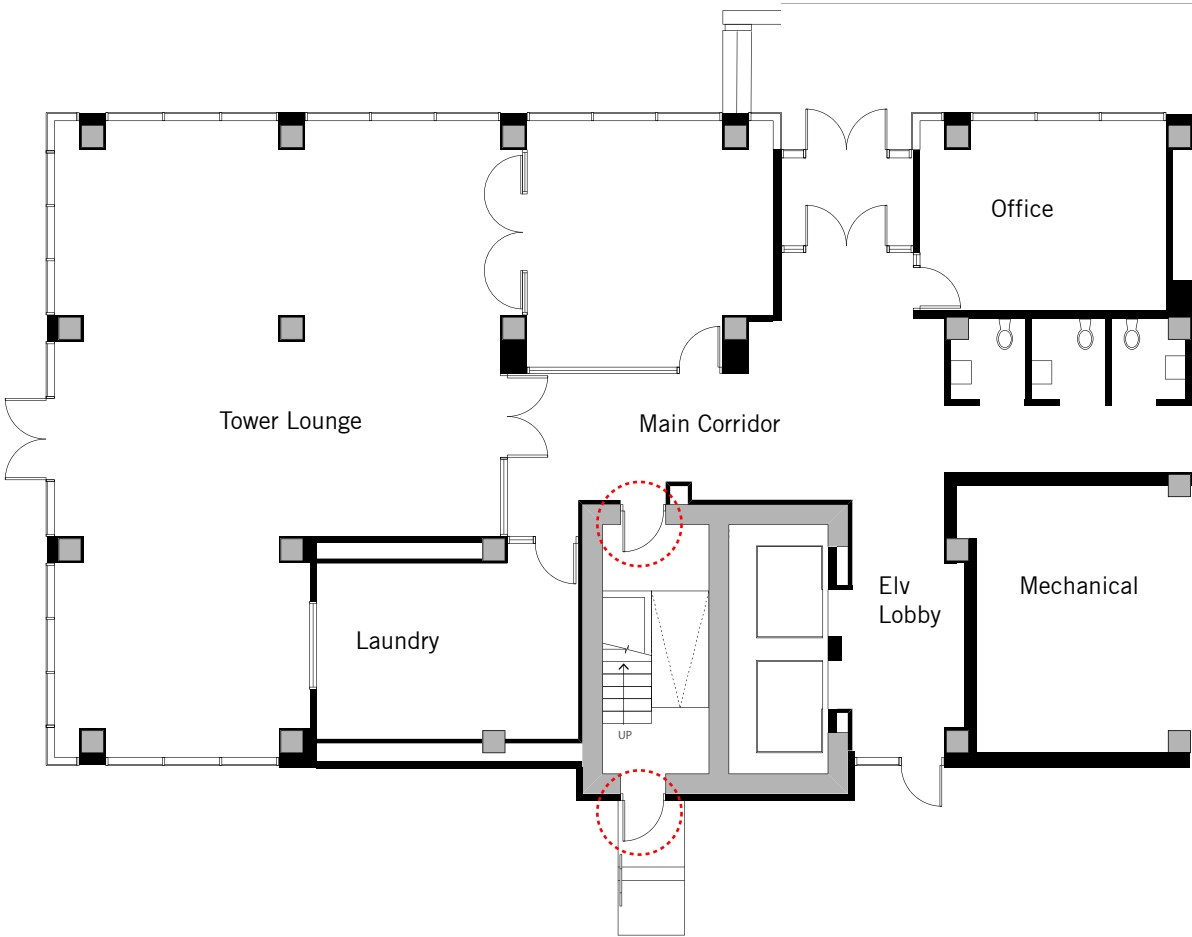
STAIR 4 - TALLWOOD HOUSE, BROCK COMMONS - LEVEL 1

Counter Location

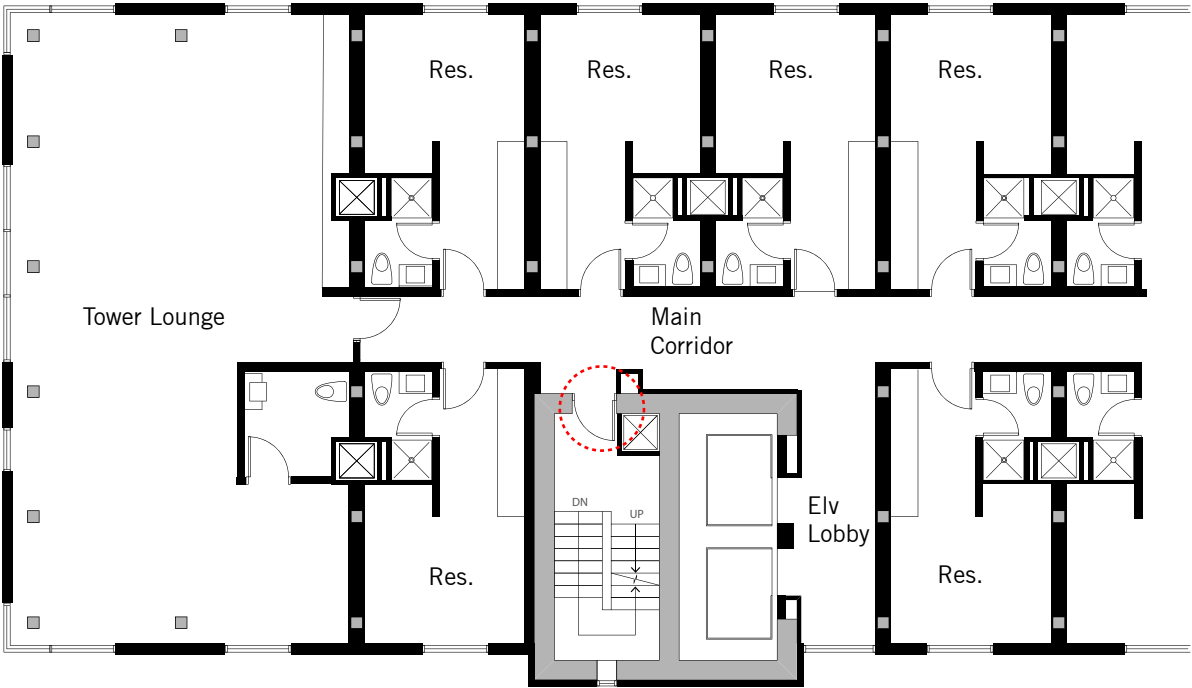
STAIR 4 - TALLWOOD HOUSE, BROCK COMMONS - LEVEL 19

Counter Location
